Eureka County

Yucca Mountain Existing Transportation Corridor

IMPACT ASSESSMENT REPORT

Appendix E — Photographs of May, 2005 Humboldt River High Water

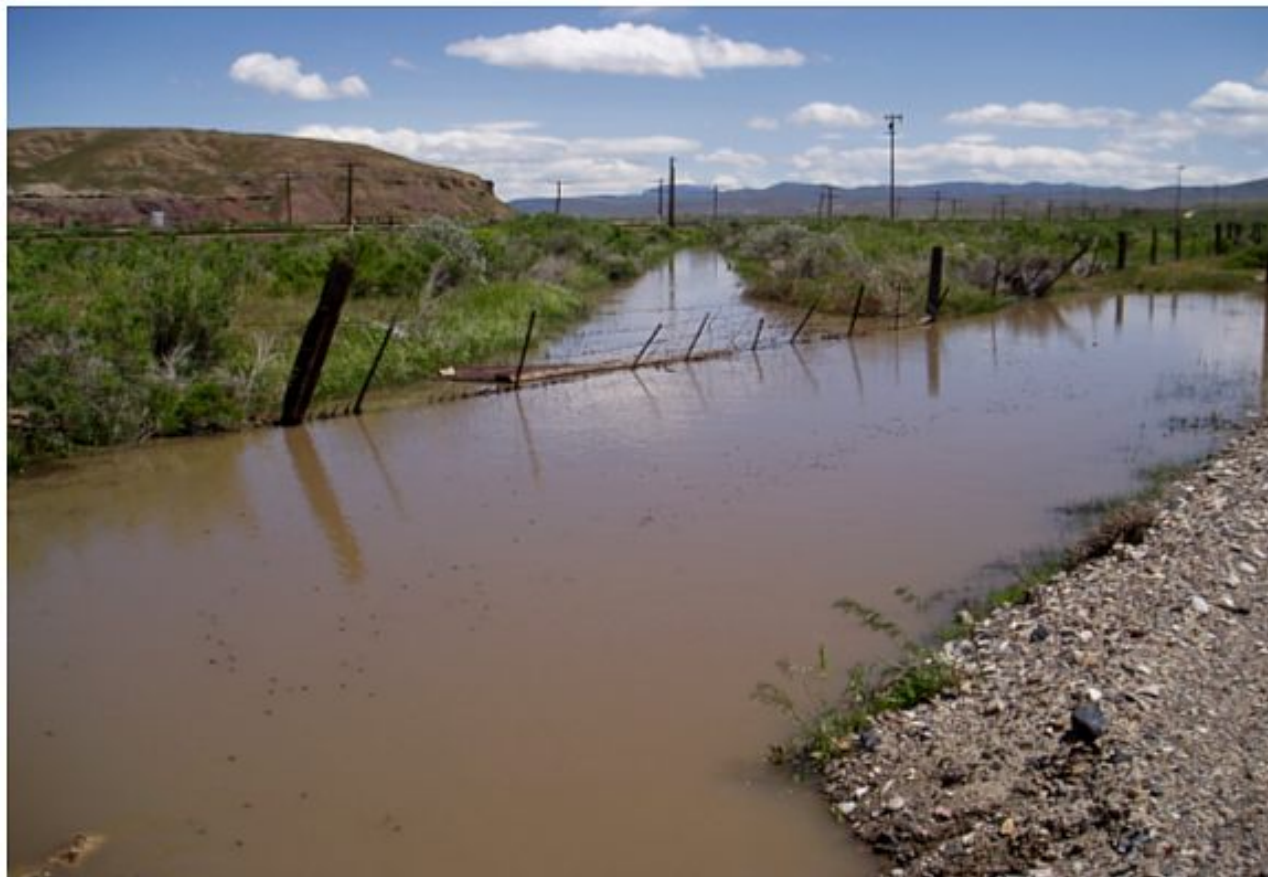
1: Floodwater near Beowawe at the potential junction with the "Carlin Spur".

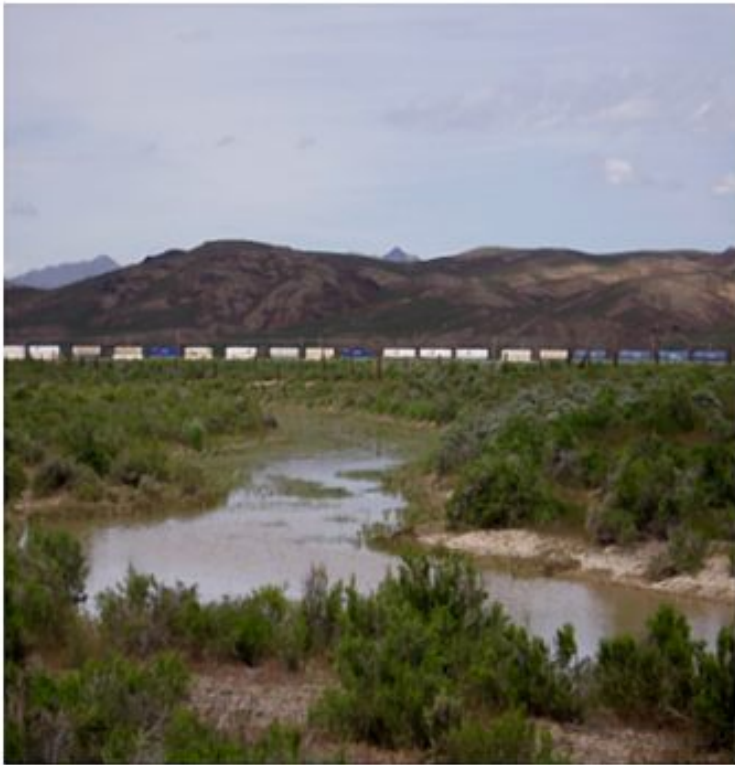
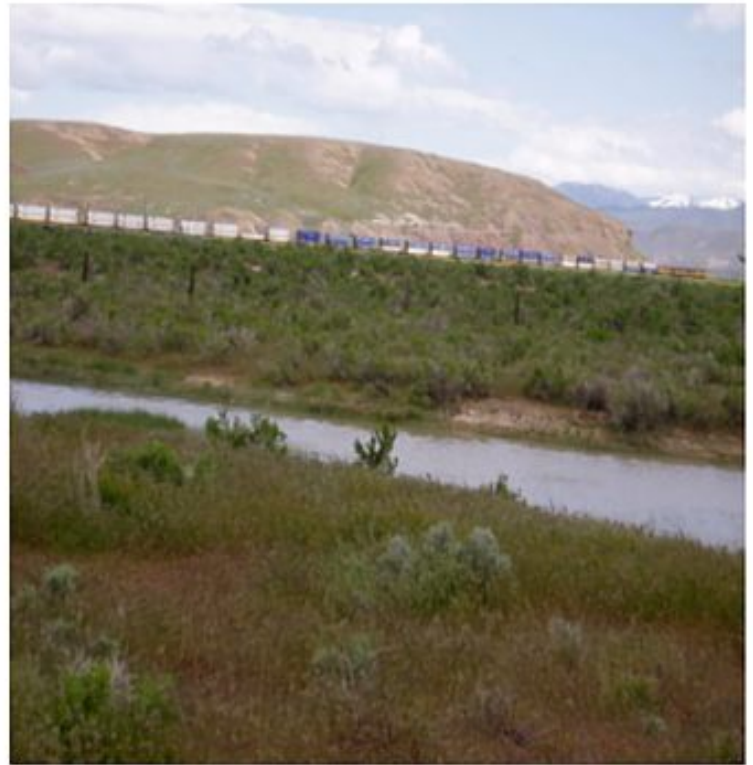
2(left) & 3(right): Both pictures are of the train stopped at Beowawe near the Humboldt River.

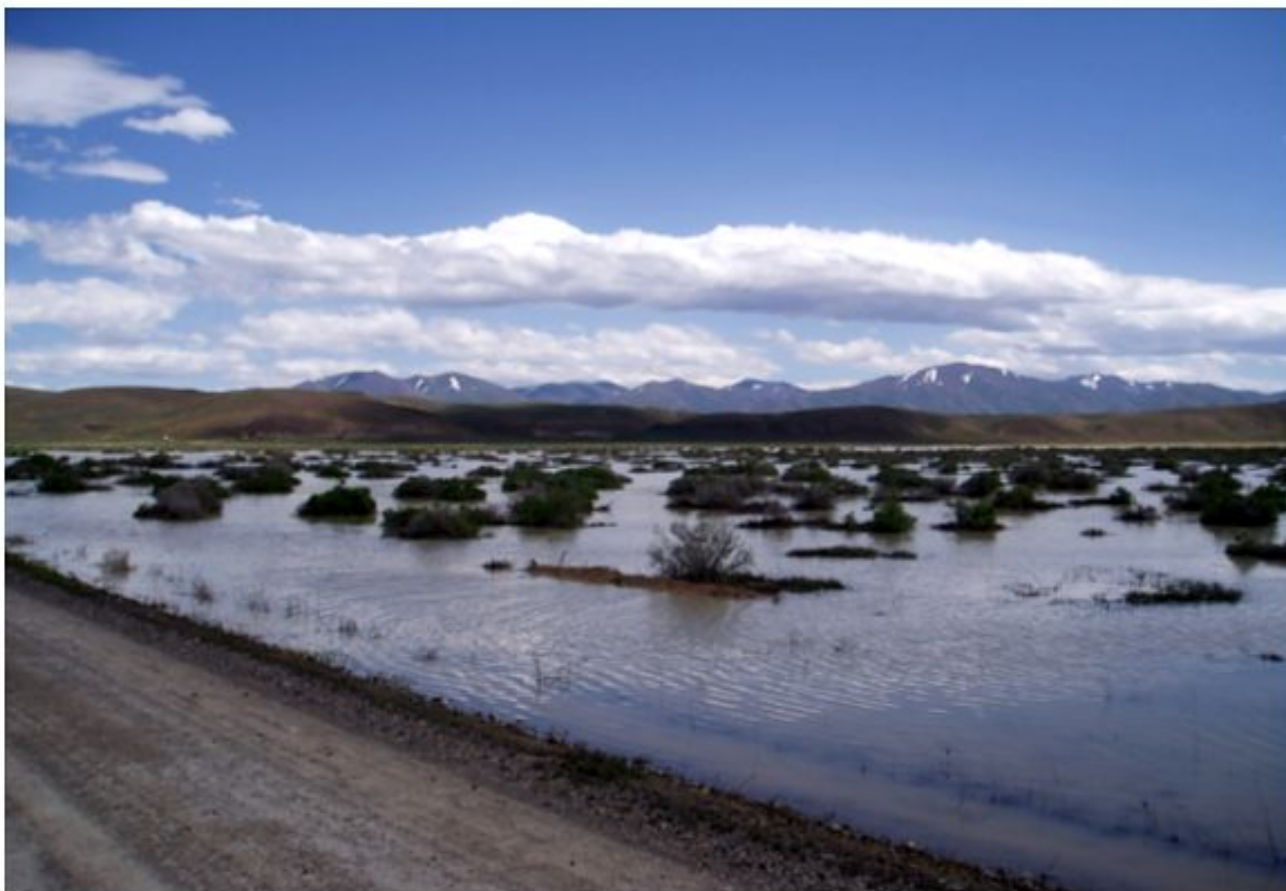
4: Flooding on flats where the potential "Carlin Spur" corridor would be.

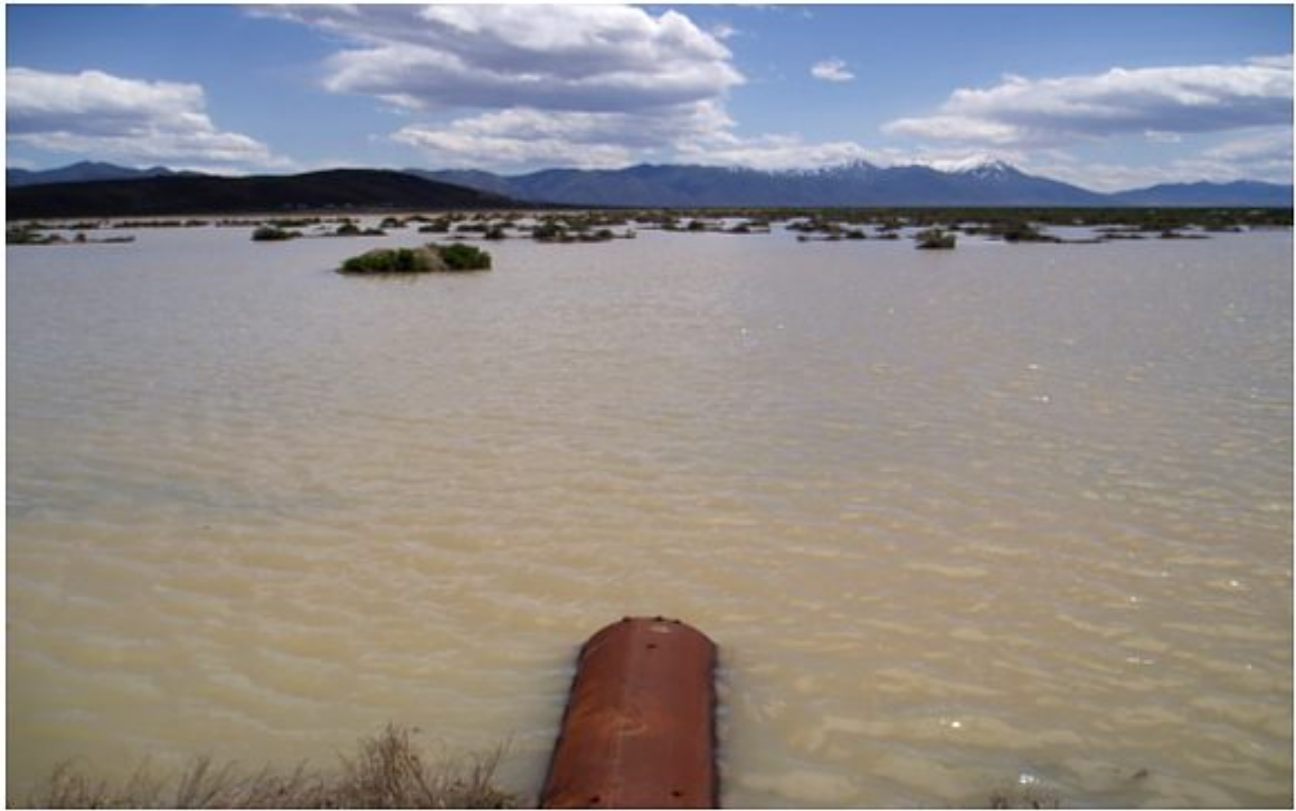
5: At the east end of McDaniel Way, where the culvert is running under the Eureka County Road. The flooding is within the potential "Carlin Spur" rail corridor area.

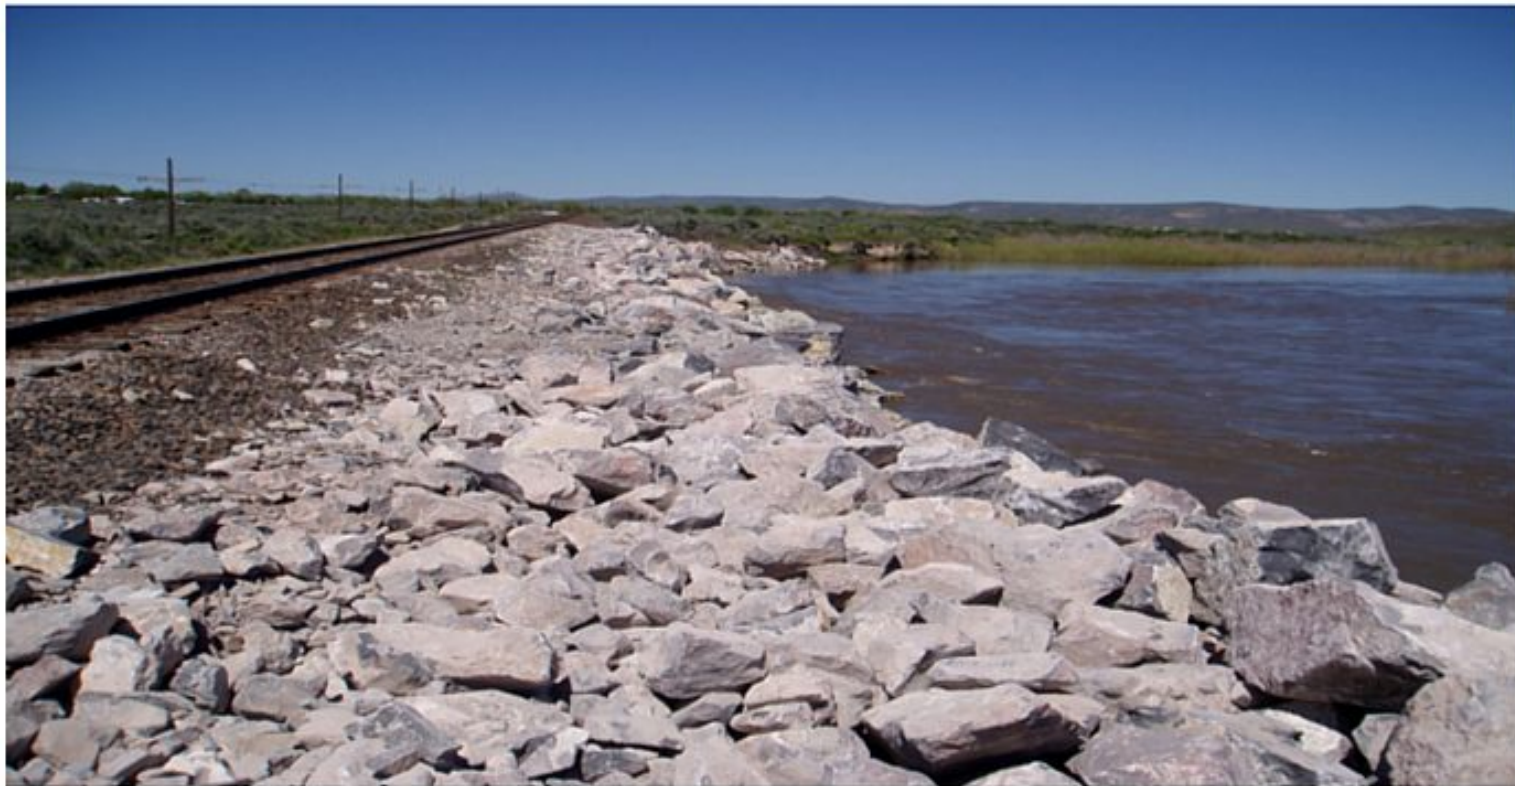
6: Flood waters from the Humboldt River were turned away at the bank of this rip-rap just east of the Carlin Bridge. The rip-rap had been placed by railroad workers May 19, 2005.

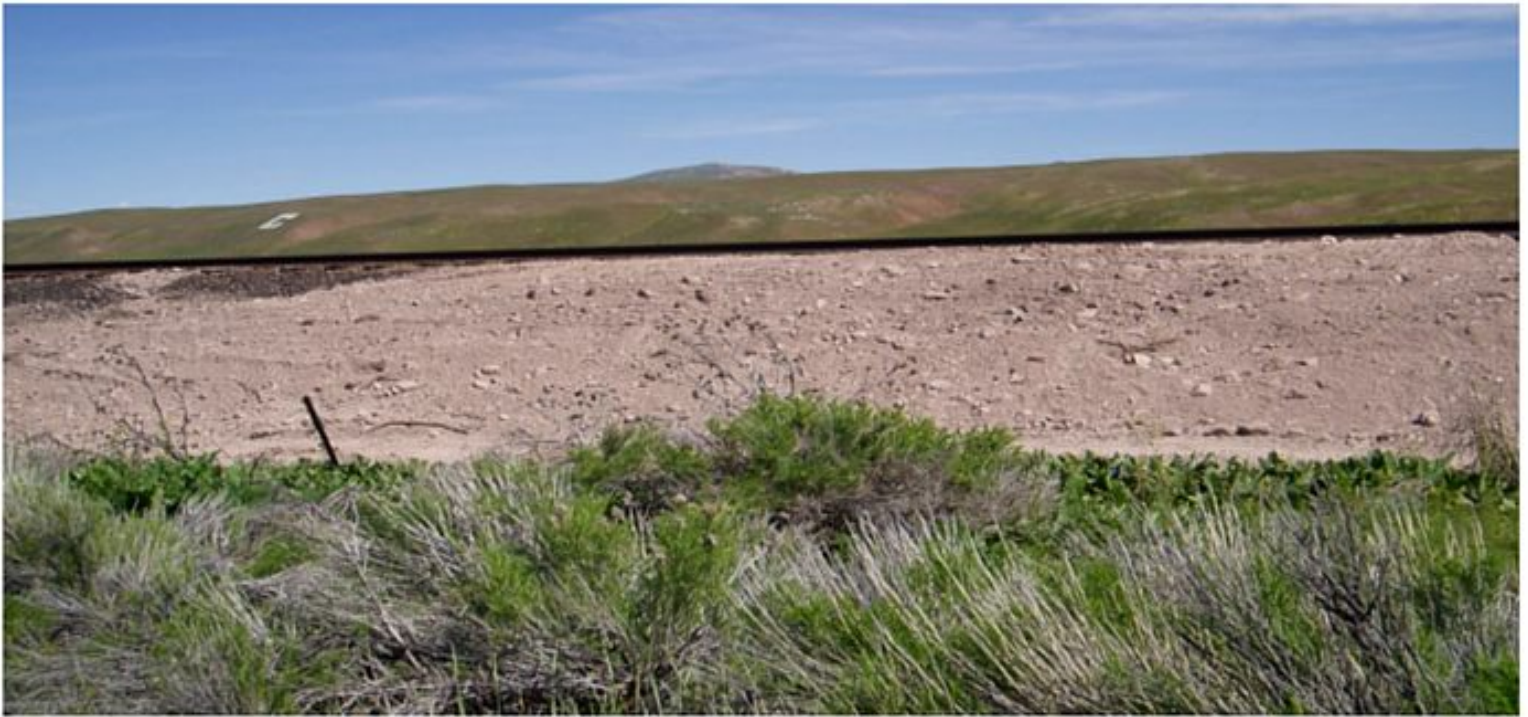
7: Opposite side of the rip-rap (above). Fresh dirt was laid on this side because the flood water had apparently saturated the existing dirt under the tracks.

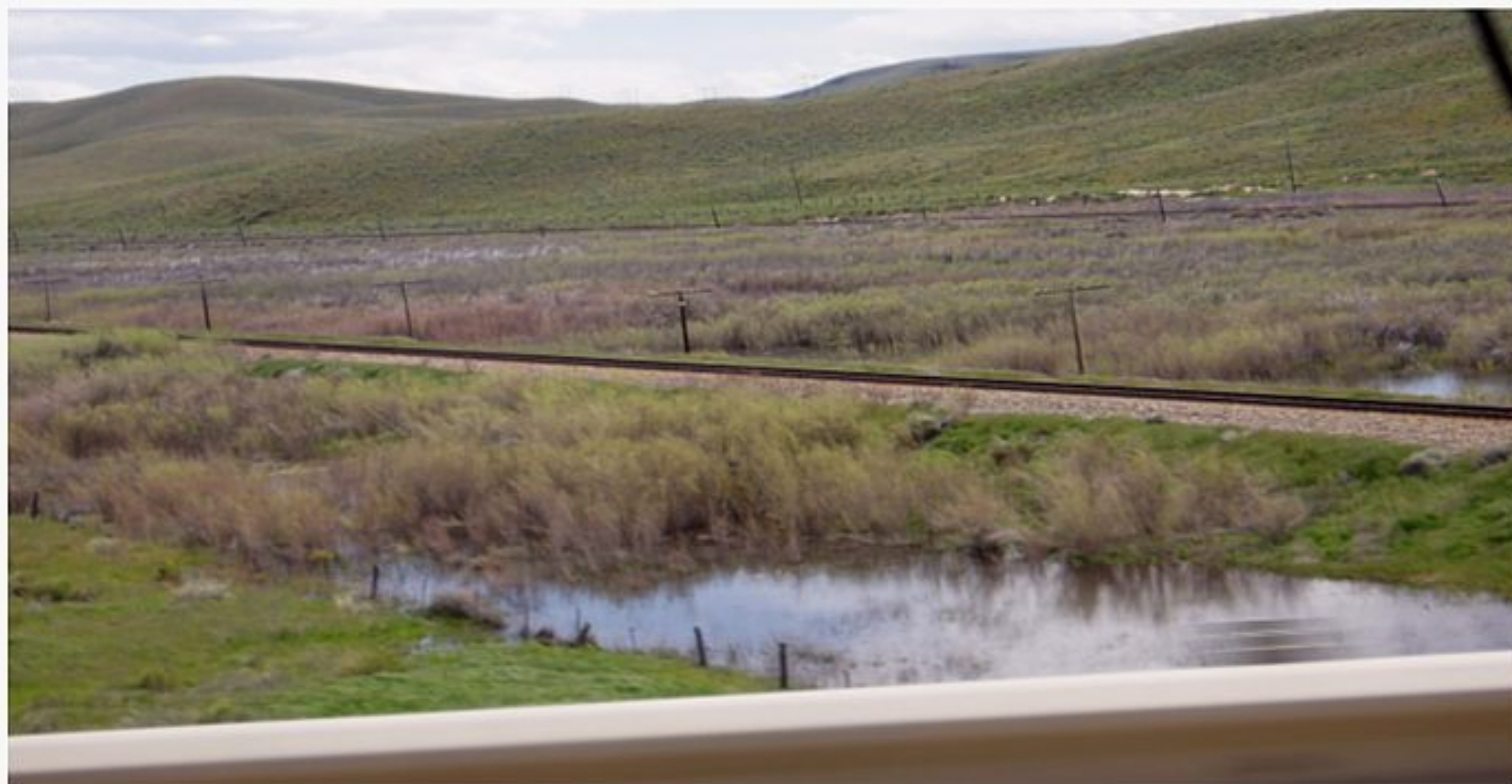
8: Standing floodwater on both sides of the track. Picture was taken from I-80, looking south, where the highway goes over both rail lines at the TS overpass.

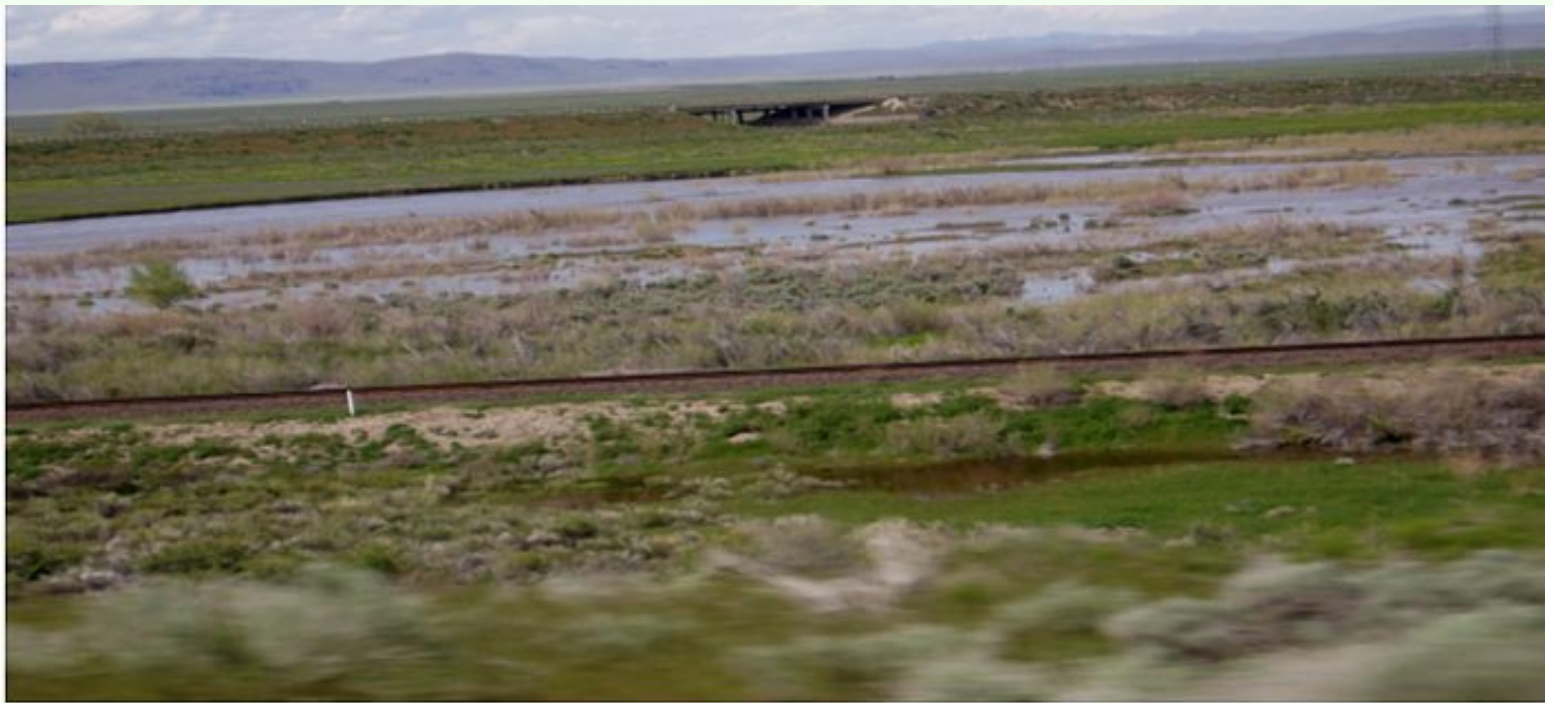
9: Humboldt River and standing floodwater on both sides of the track. Picture taken from I-80, looking South, near the TS crossing.

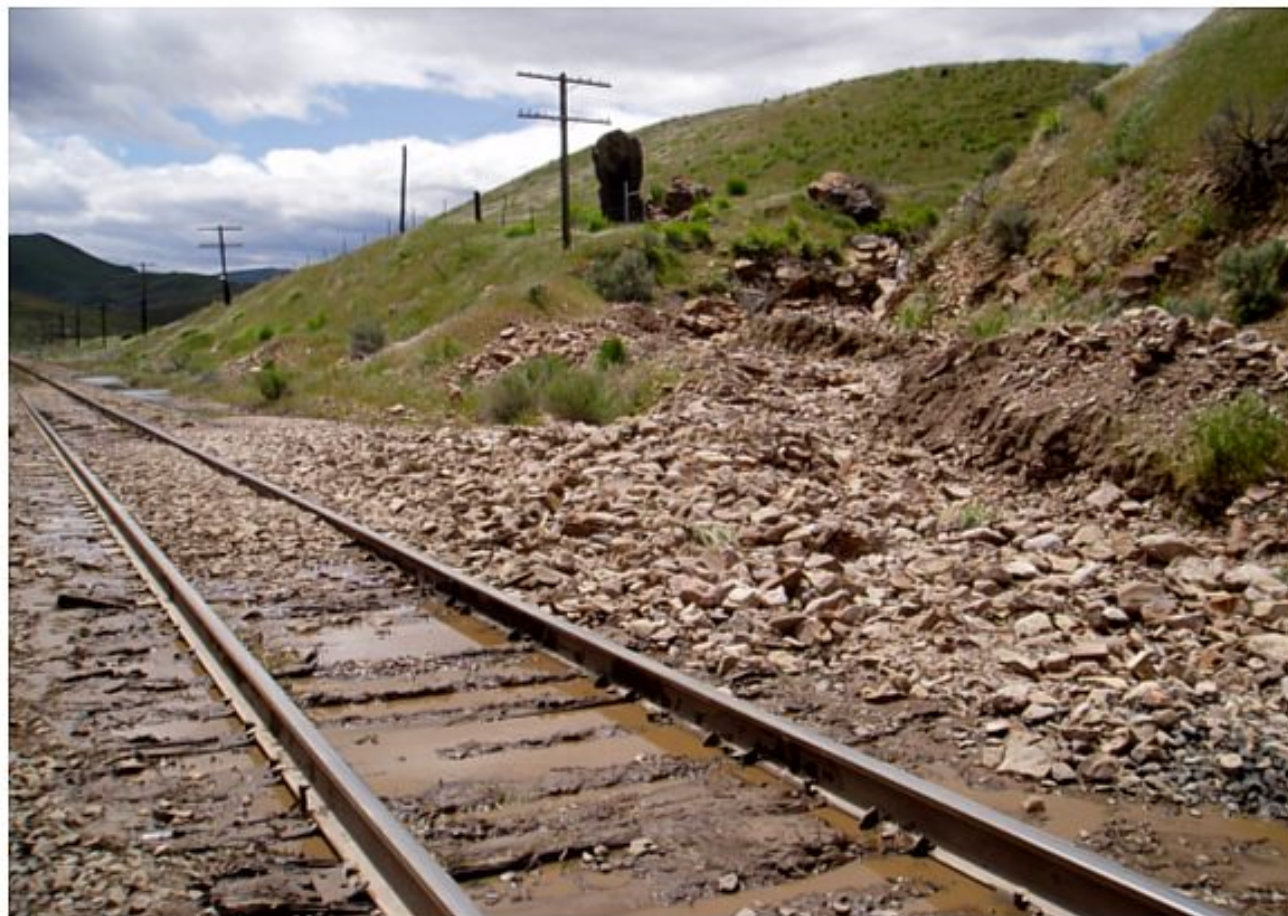
10: Rockslide and muddy tracks, north of Palisade townsite on westbound track.

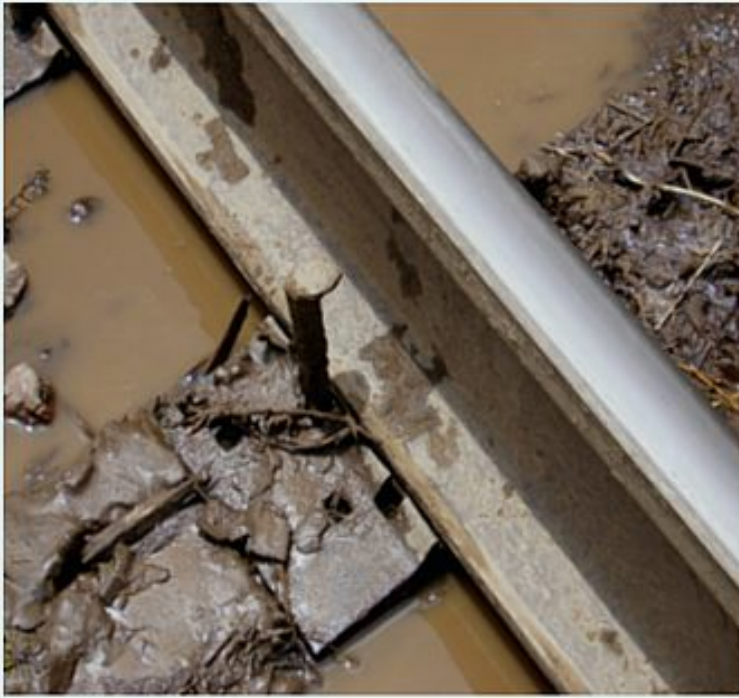
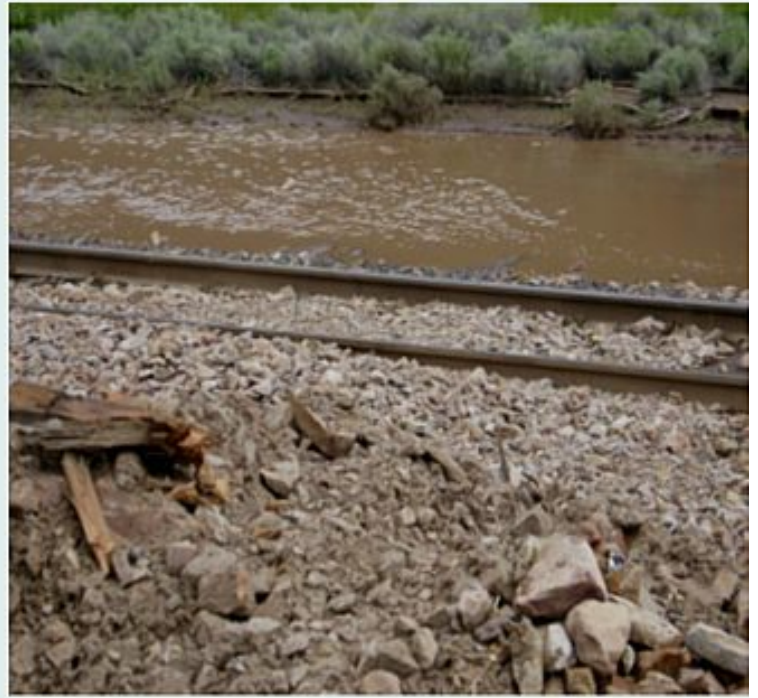
11: Close-up of a raised rail-spike from picture 10. 12: Rockslide and ponded flood waters. Opposite view of picture 10.

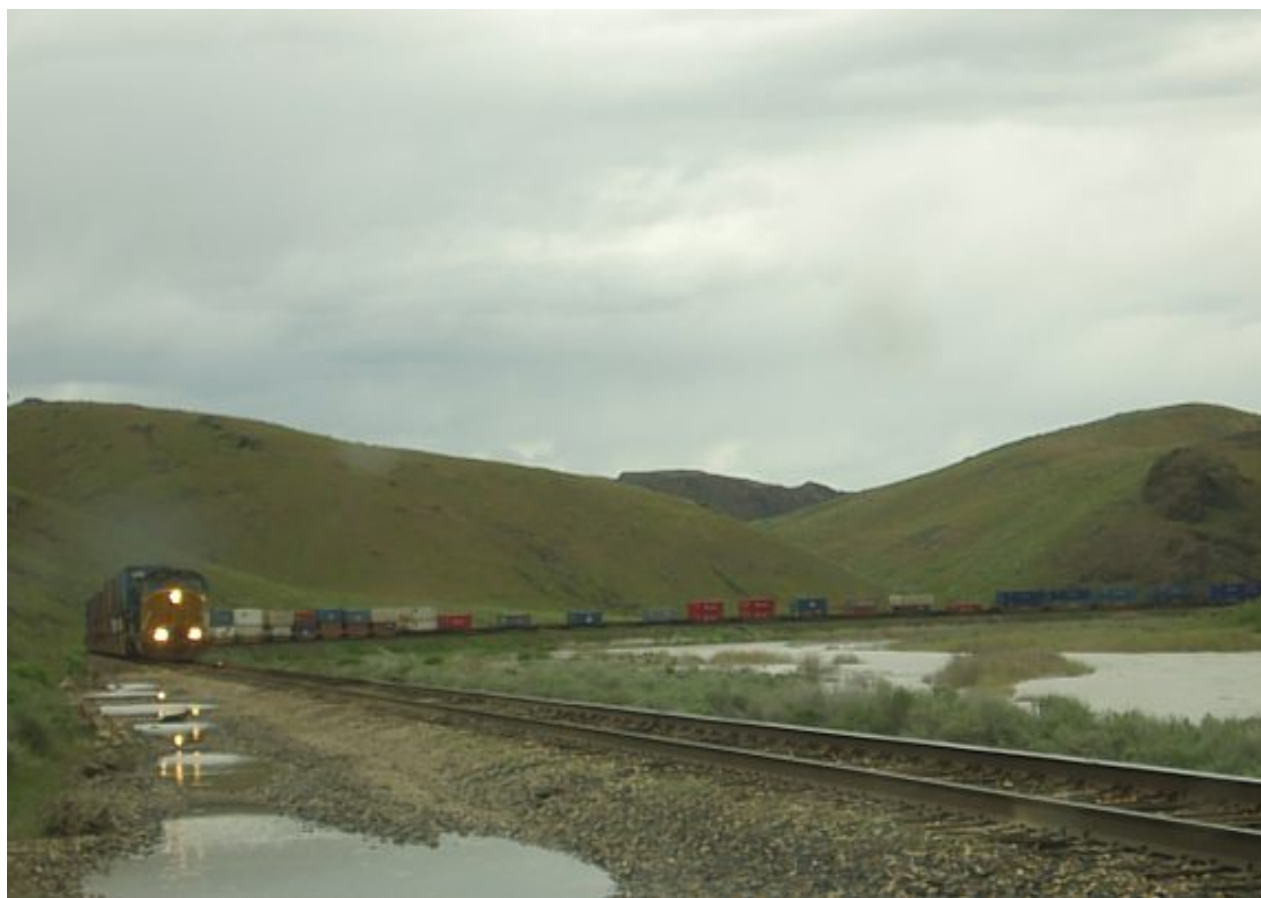
12: Humboldt River and standing water. Westbound track at Barth, very close to the site where The City of San Francisco derailed in the early 1900's.

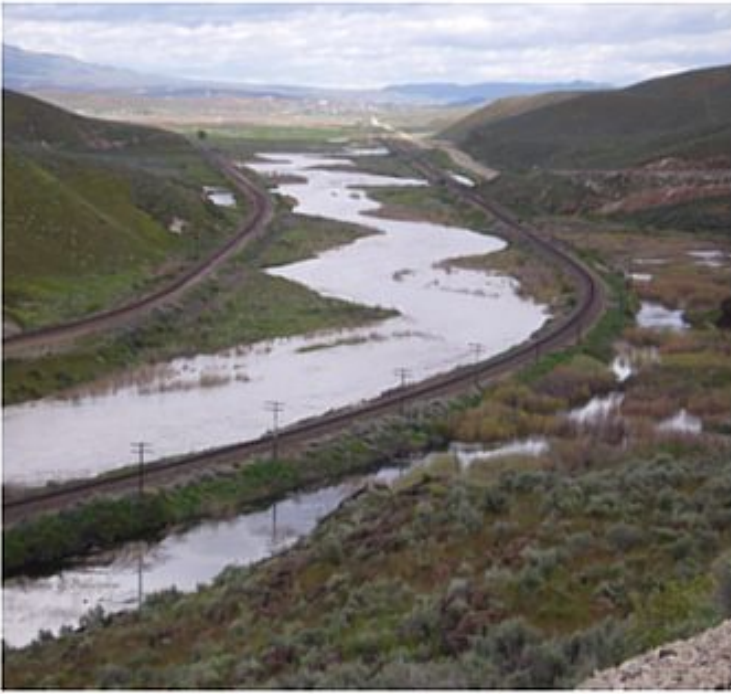
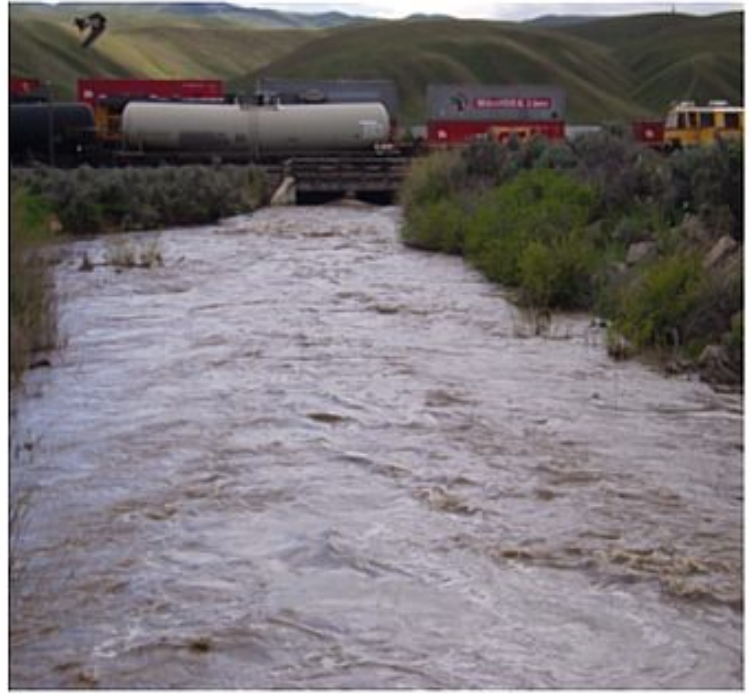
13: Left Picture taken from Highway 278 looking north towards Carlin.
14: Right Picture is Maggie Creek at the town of Carlin.
